## SB-934111 SERVICE BULLETIN

To: All Bee Access Dealers  
Re: Service Bulletin on Walk Thru C-stirrups, part no. 934111

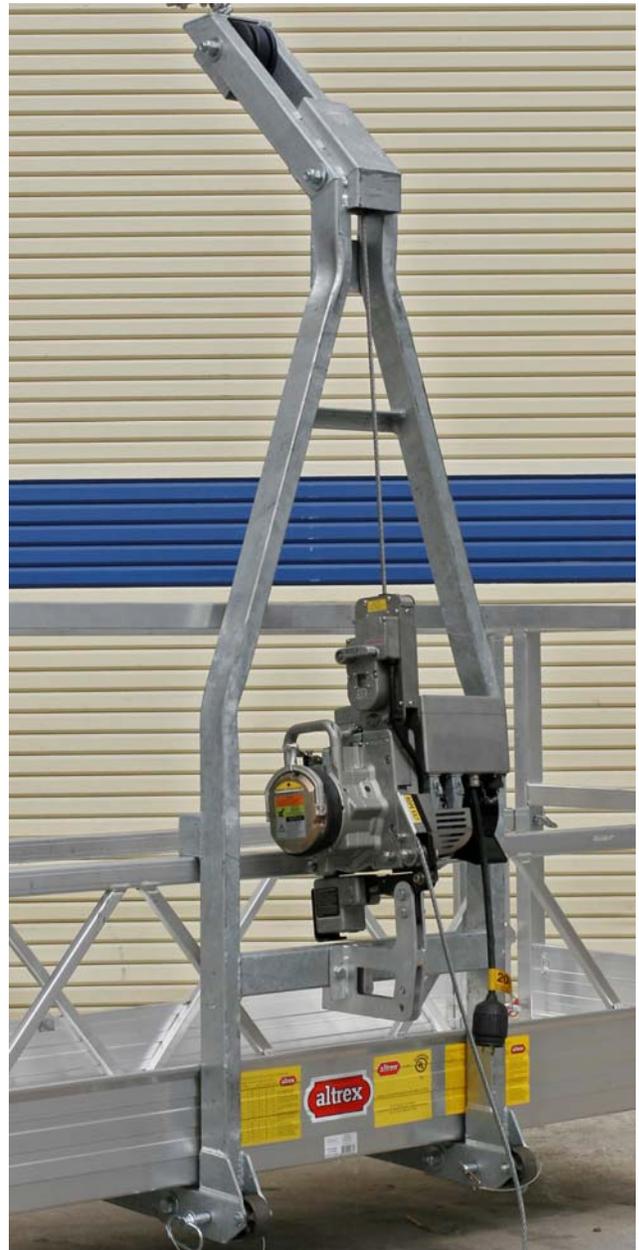
This picture shows a properly installed Bee Access Walk Thru C-stirrup, including a multi-hoist mounting bracket.

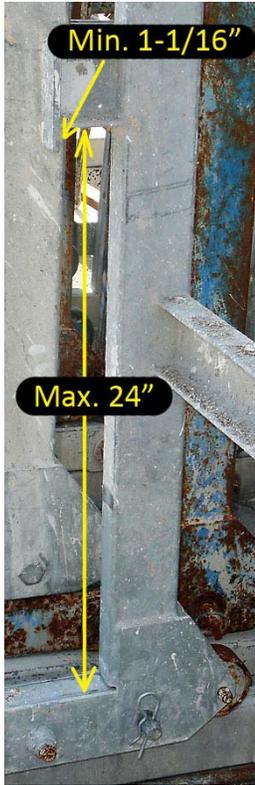
Picture 1

Check the lip of the Walk Thru C-stirrup that hooks onto the midrail. It should be sticking out 1-1/16" with a 1/16" tolerance. If too short it will not properly lock onto the midrail and the stirrup can slip off.

Check the distance from the midrail bracket to the bottom gusset plate (or top of the bottom support frame). It should not be more than 24" with a 1/16" tolerance.

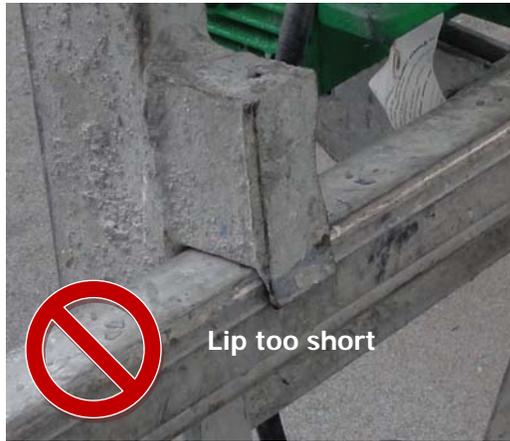
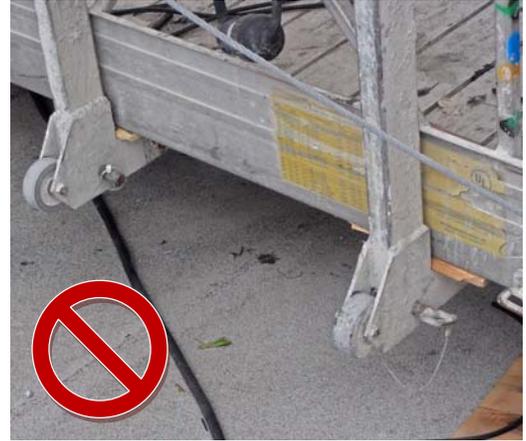
Pictures 2 and 3 below show a job site situation where the lip was too short and the distance between the gusset and midrail mount exceeded 24". The contractor resorted to using wood shims to keep it from dislodging from the platform. The use of shims is not safe and is not recommended.

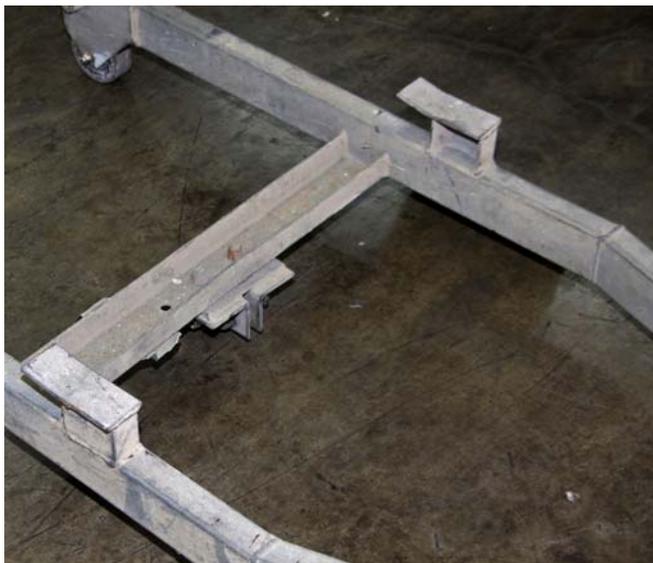
Picture 4

Some older model stirrups were made with a horizontal C-channel to accommodate the hoist mounting bracket. ONLY use the originally supplied mounting bracket with this model (Picture 4), do NOT use the Bee Access extended or multi-hoist mounting bracket, as the channel is not rated for the extra moment loads and will bend and deform during use (Picture 5). There will not be anything close to a 4:1 safety factor. In order to avoid mixing components, the best solution is to repair or scrap this style stirrup.

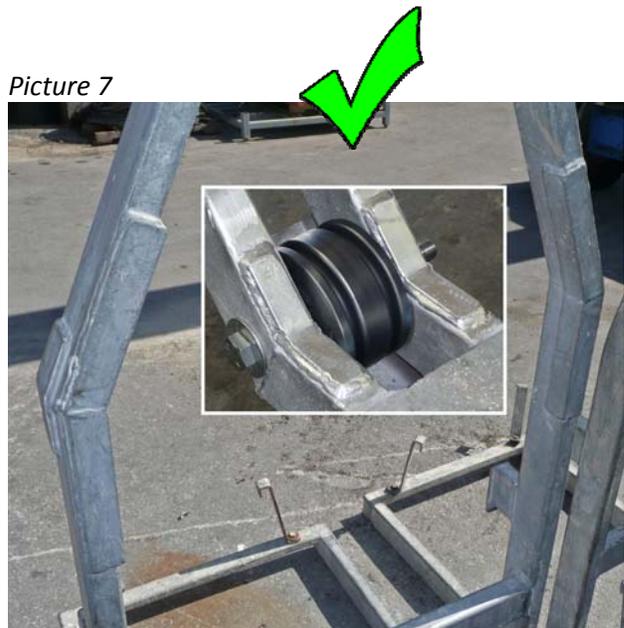
Picture 7

Bee Access manufactures 2 types of stirrup frames: one using bent vertical tubes (picture 8) and one with welded tubes. Note that on the welded version, we add re-enforcement straps welded on the vertical tubes, as well as on the inside of the neck as shown in picture 7.

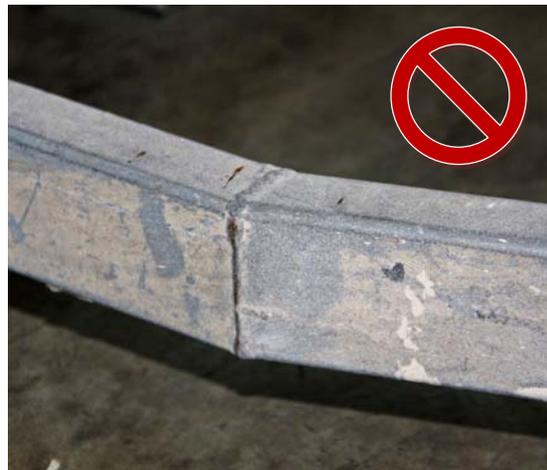
Picture 9

Some other manufacturers that weld the tubes do not use re-enforcement straps (picture 9) and in our opinion, should be upgraded or scrapped as we have seen weld failures in this area.

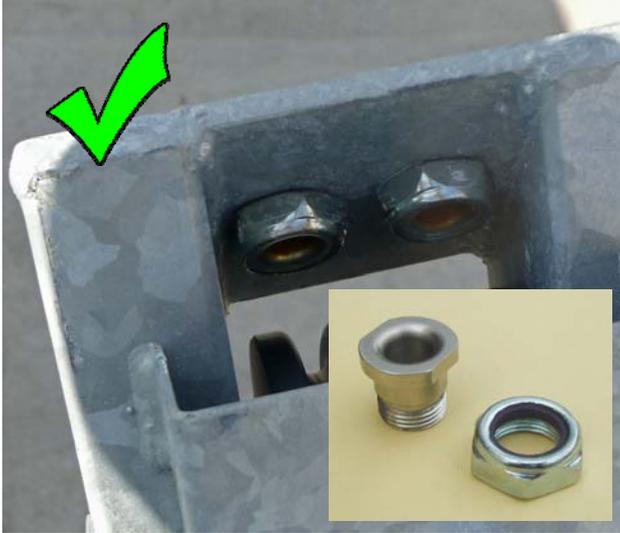
Picture 10

Older model Bee Access stirrups and current ones from competitors have inlet cable guides that are installed with retaining rings (picture 11). We have found that our newer style inlet guide with low profile lock nut is a more secure way of keeping the guide in place (picture 10). If the inlet guide is absent, severely damaged or worn, it could allow the wire rope to make direct contact with the steel frame, which could cause the wire rope to fail. We highly recommend you replace the inlet cable guides that have retaining rings with a type that has a lock nut.

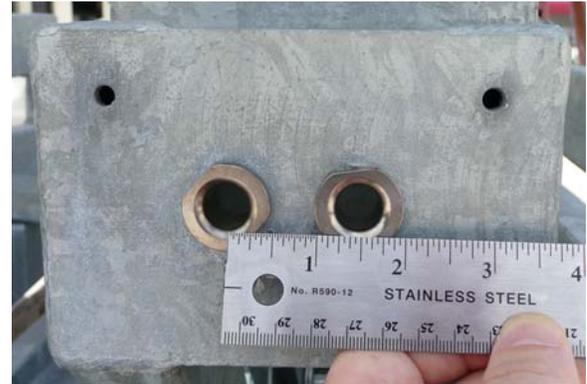
Picture 12

Our current stirrups include 4-7/8" dia. Double Groove Sheaves with sealed stainless steel bearings (picture 13). The grooves are separated 1-1/2" on center. Older stirrups may require 5" dia. Double Groove Sheaves with 2" groove separation (picture 14). You can tell which one you need by measuring the distance of the inlet cable guides across the center of the holes (picture 12).
